ST10F276E, ST10F275E, ST10F273E Errata sheet

16-bit MCUs with
512/768/832 KByte Flash and 36/36/68 KByte RAM memories

This errata sheet describes all the functional and electrical problems known in the Cxx silicon versions of the ST10F276E, ST10F275E and ST10F273E.

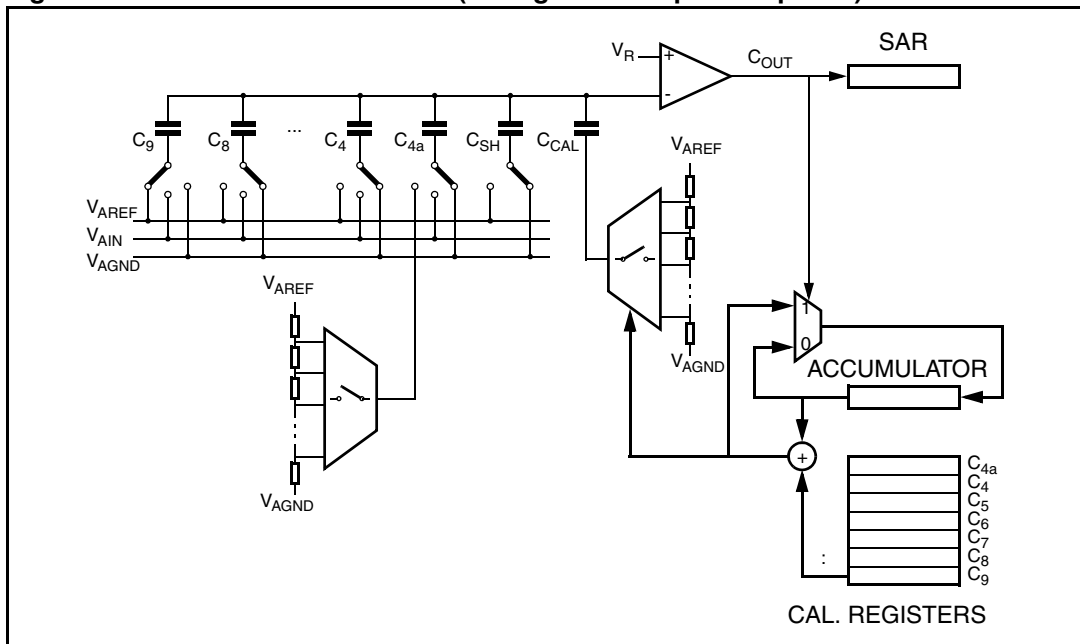
Figure 1. Calibration mechanism (during bit 9 comparison phase)

On specific analog input values an accuracy degradation of several LSBs may be seen on the digital output value of the implemented ADC. In particular this occurs if the input voltage matches the internal comparator thresholds, which is when a roll over from the least significant bits (i.e. 0x1Fh -> 0x20h or vice versa) occurs.

The maximum deviation in accuracy is $\pm 250\text{mV}$ over the entire conversion range.

The failure is linked to the implemented “self calibrating circuitry” which is summarized in the [Figure 1: Calibration mechanism \(during bit 9 comparison phase\)](#).

The maximum correction applied by the calibration is 250mV.

When the analog input voltage is close to one of the thresholds of the comparator (by less than 1mV), then the amplifier sees a differential voltage very close to zero. As a result, the output of the comparator will be fluctuating between the values “0” or “1”. Because of the parallel use of the comparator output and of the fluctuating value, different values may be latched in the SAR (Successive Approximation Register) and the Calibration section. As a result a bad calibration mechanism is applied to the successive bit

It is not possible to define a workaround generic for all applications.

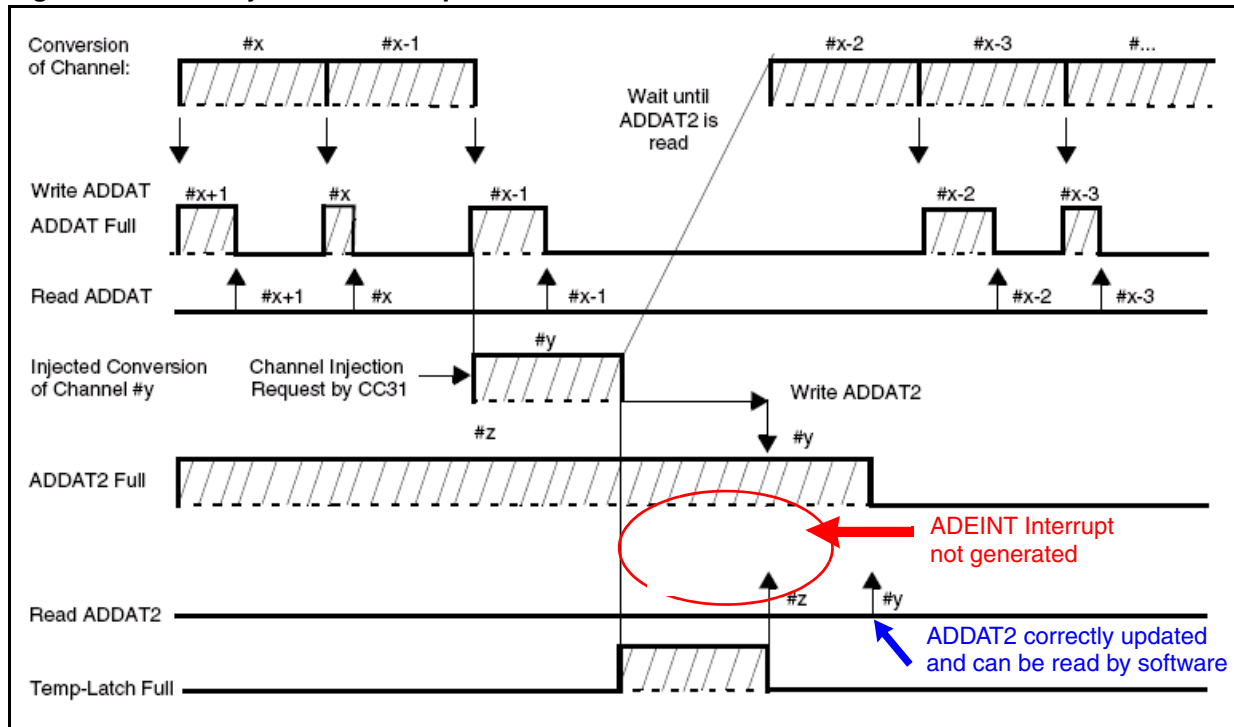
Figure 2. ADC injection theoretical operation

Whenever a new Injection request is issued before the ADDAT2 register has been read by the CPU (i.e. the result of the previous injection request was not read), the ADC is stalled and no further conversions are performed.

If the temporary data register used for ADDAT2 Read Mode is full and a new Injection request is issued then the new converted value is stored into a temporary data register until the previous one is read from ADDAT2.

For a correct functionality as soon as ADDAT2 register is read then the last converted value should be moved from temporary register to ADDAT2 and the ADEINT interrupt request should be issued. This would allow the CPU to read the last converted value. See [Figure 2](#).

In the real situation as soon as ADDAT2 register is read then the last converted value is correctly moved from temporary register to ADDAT2 but **the ADEINT interrupt request is not received by the Interrupt Controller (see [Figure 3](#))**. As a consequence the CPU/PEC will never know that a new converted value is ready to be read in ADDAT2 register and therefore at the following injection request the ADC will fill the temporary register again (without generating any ADEINT interrupt request) and then will stall the ADC for any further conversion. The ADC will stay in the “wait for read ADDAT2 register” condition forever.

1. Read the ADDAT2 register twice at the end of every injected conversion (also prevents stall condition to occur)
2. Disable then re-enable the Wait For Read mode

Therefore ensuring, at application level, that no task can disable interrupts for a time such than 2 injection requests can be issued before a read operation is performed prevents the locking situation to occur.

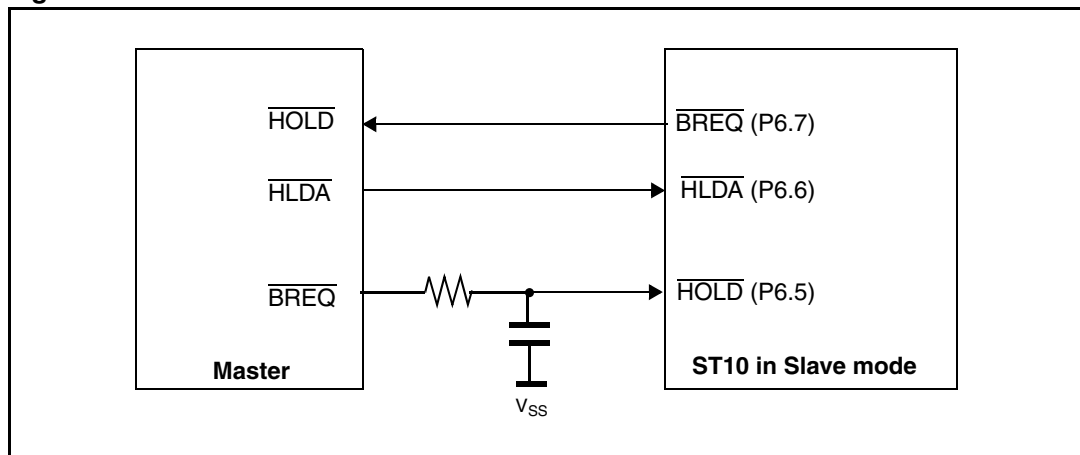
Figure 4. ST10 in slave mode

When using external bus arbitration via HOLD-function with the ST10F276 configured as a slave, sporadic bus errors may occurs.

After the slave has been granted the bus, the slave deactivates BREQ sporadically for a short time, even though the bus access of the slave has not been completed. The master then starts its own bus access, leading to a bus conflict between master and slave.

In order not to produce any spurious BREQ pulse during a Slave External Bus Arbitration Phase, it is necessary to guarantee that the distance between the HOLDA assertion (Bus Acknowledge from Master device) and the following HOLD falling edge (Bus Request from Master) is greater than three clock cycles.

This can be implemented by delaying the HOLD signal with a RC circuit as shown in the figure below.
